Channel Stability Problems, Iao Stream, Maui, Hawaii

**U.S. Army Engineer Committee on Channel Stabilization
Report of the 64th Meeting—September 1999**

ERDC/CHL SR-00-2
CCS-00-2
June 2000

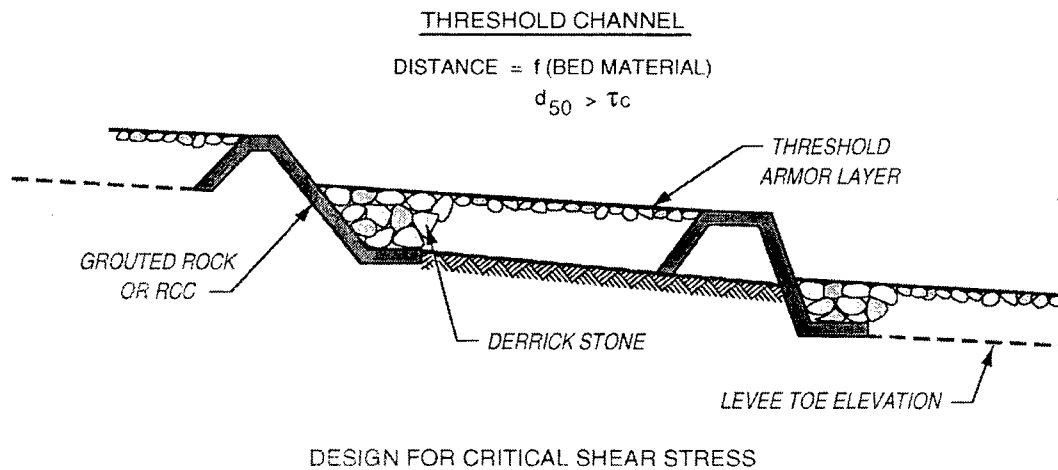
Figure 3. Profile of threshold channel design with slope reduced by drop structures

The following figures provide conceptual designs that meet the design objectives. One design (Figures 1 and 2) is for a partially armored bed at the existing slope. It features a semipervious center section armored with large derrick stone. The second design (Figures 3 and 4) consists of grade control structures that reduce the slope to the point where a pervious natural bed is possible. The second design concept is expected to be more expensive to construct.

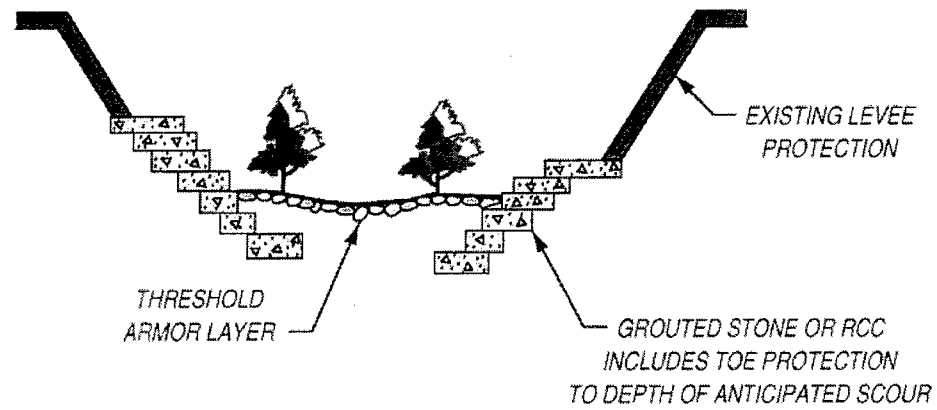
Figure 4. Cross section of threshold channel design

NOTE: TOE PROTECTION WITHOUT DROP STRUCTURES
REJECTED BECAUSE OF UNCERTAINTY

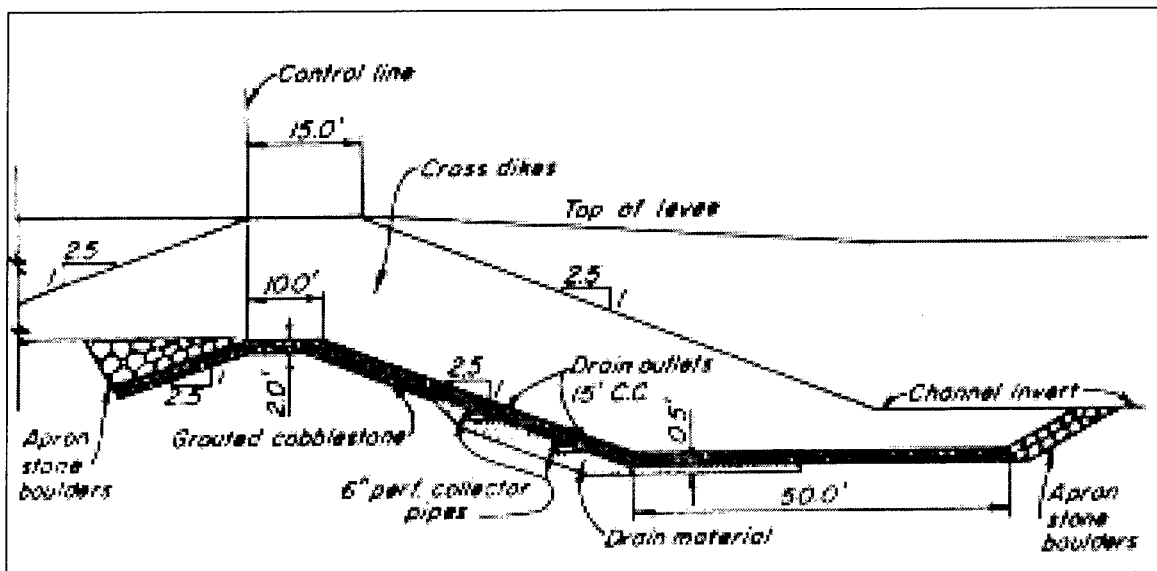
Figure 6. Section through drop structure

Grouted stone drop structures have performed satisfactorily on the San Gabriel River in Los Angeles County for over 30 years. This river is a cobble-boulder bed stream with a pre-project slope in the project reach of about 0.0125. The channel was designed using maximum velocity criteria. A maximum velocity of 10 fps was selected to allow for only minor transport of fine streambed material and to minimize the potential for toe scour against the levees. Drop structures were placed about 1,000 ft apart providing a project slope of about 0.0030. These structures have a 1V:2.5H sloping crest, are 15.5-ft-high with a 5-ft-high stilling basin, so the vertical drop between crest and downstream invert is 10.5 ft. The length of the stilling basin is a function of the downstream water-surface elevation. The channel base width is 800 ft and the flow is constricted at the drop structures' crest to 500 ft. The flood control project is designed for the SPF peak of 98,000 cfs. One of the objectives of this project was to maintain groundwater recharge in the natural channel. In the project design, consideration was also given to a trapezoidal reinforced-concrete channel with off-channel spreading basins. The cost of the natural channel bed and drop structure design was substantially less than the paved channel. A section through a typical drop is shown below.

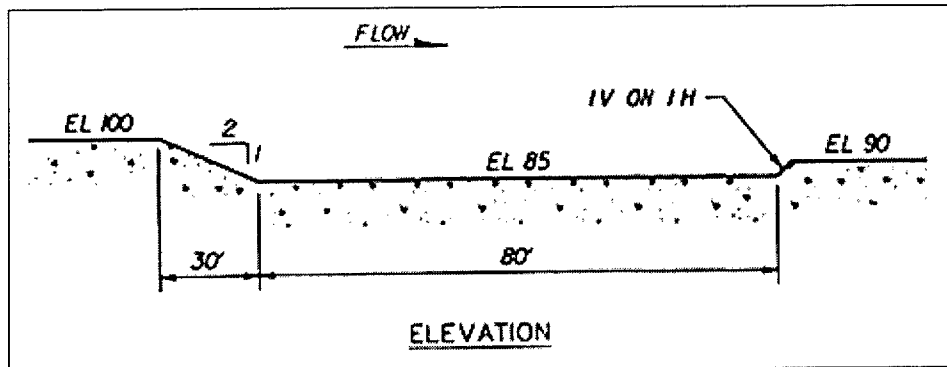
Figure 7. Section through grouted rock structure

Hydraulic model studies were conducted at U.S. Army Engineer Research and Development Center in 1983-87 to evaluate drop structure designs for the Santa Ana River in Orange County, California (George, Pickering, and Turner 1994). A recommended design was developed for a grouted rock drop structure. This structure also had a 10.0-ft drop between the crest and downstream invert. Satisfactory hydraulic performance was demonstrated for unit discharges between 50 and 250 cfs/ft. Although the grouted stone structure was determined to perform satisfactorily, a reinforced concrete structure was finally chosen for construction by the U.S. Army Engineer District, Los Angeles. A section through this grouted rock structure is shown below.
